U.S. Department  
of Transportation

National Highway  
Traffic Safety  
Administration

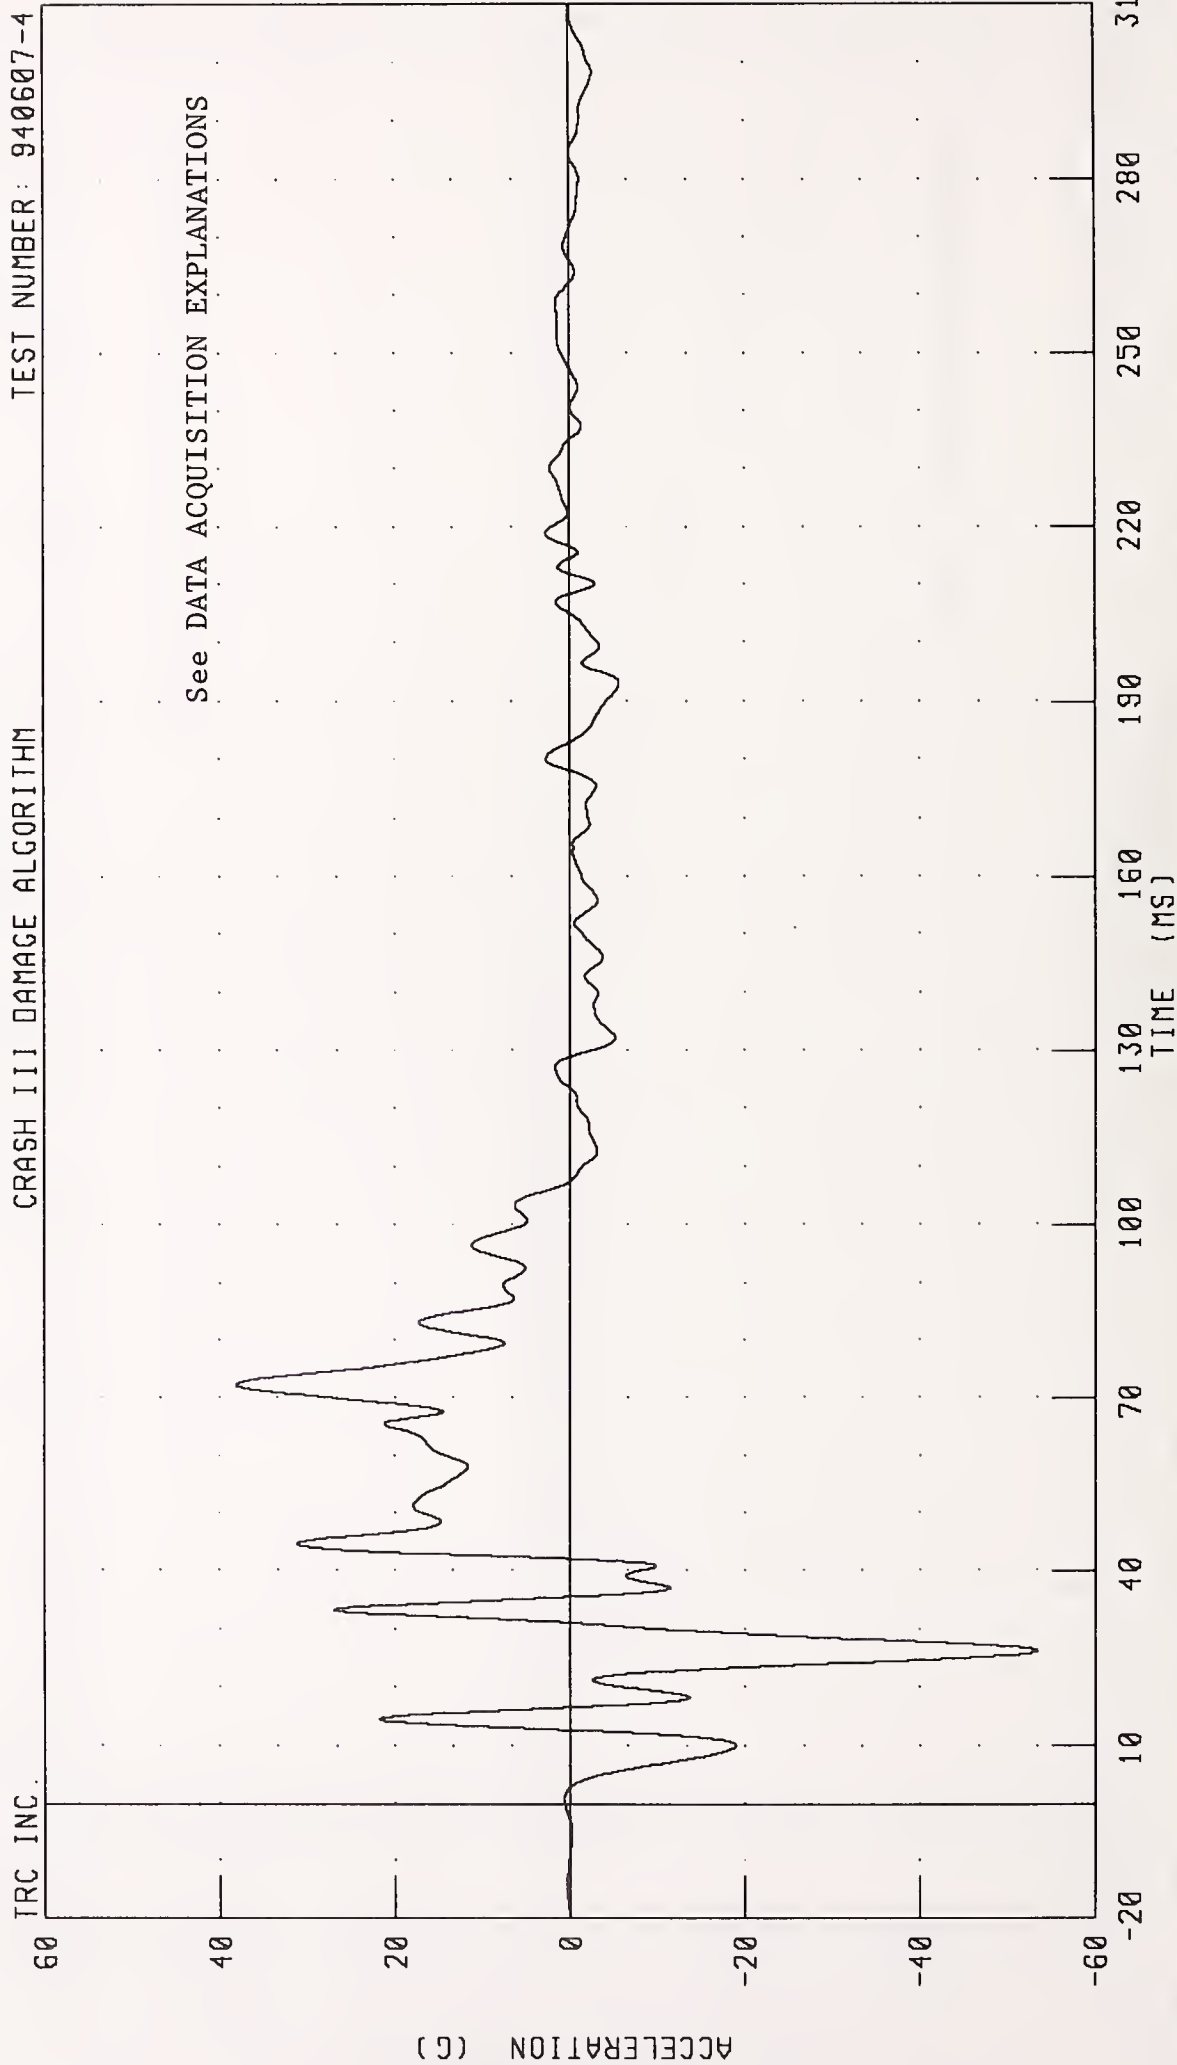
CHANNEL: VCGZG1 FILTER: CH. CLASS 60

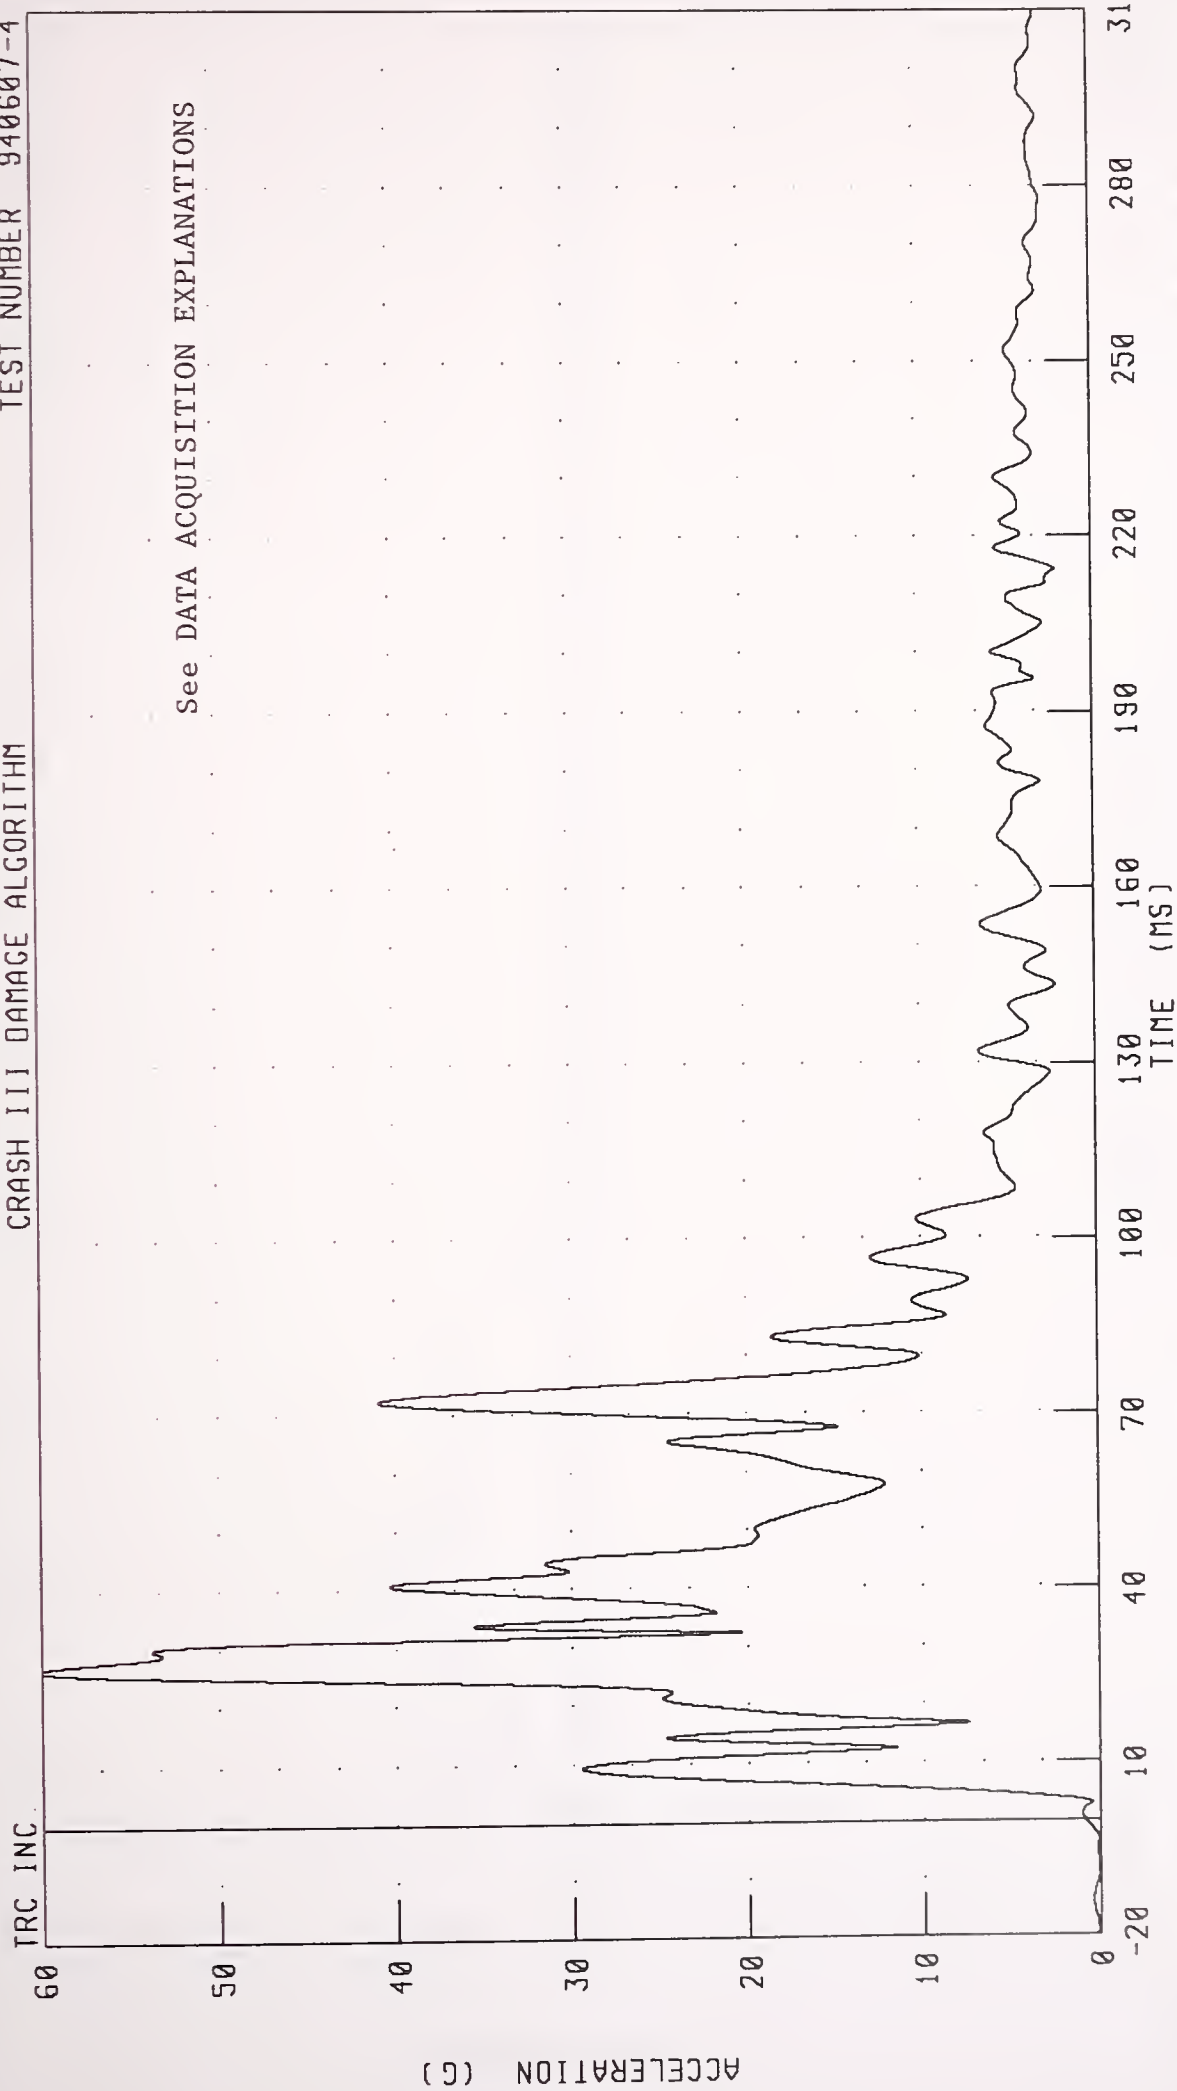
CHANNEL: VCGRG1 FILTER: CH CLASS 60

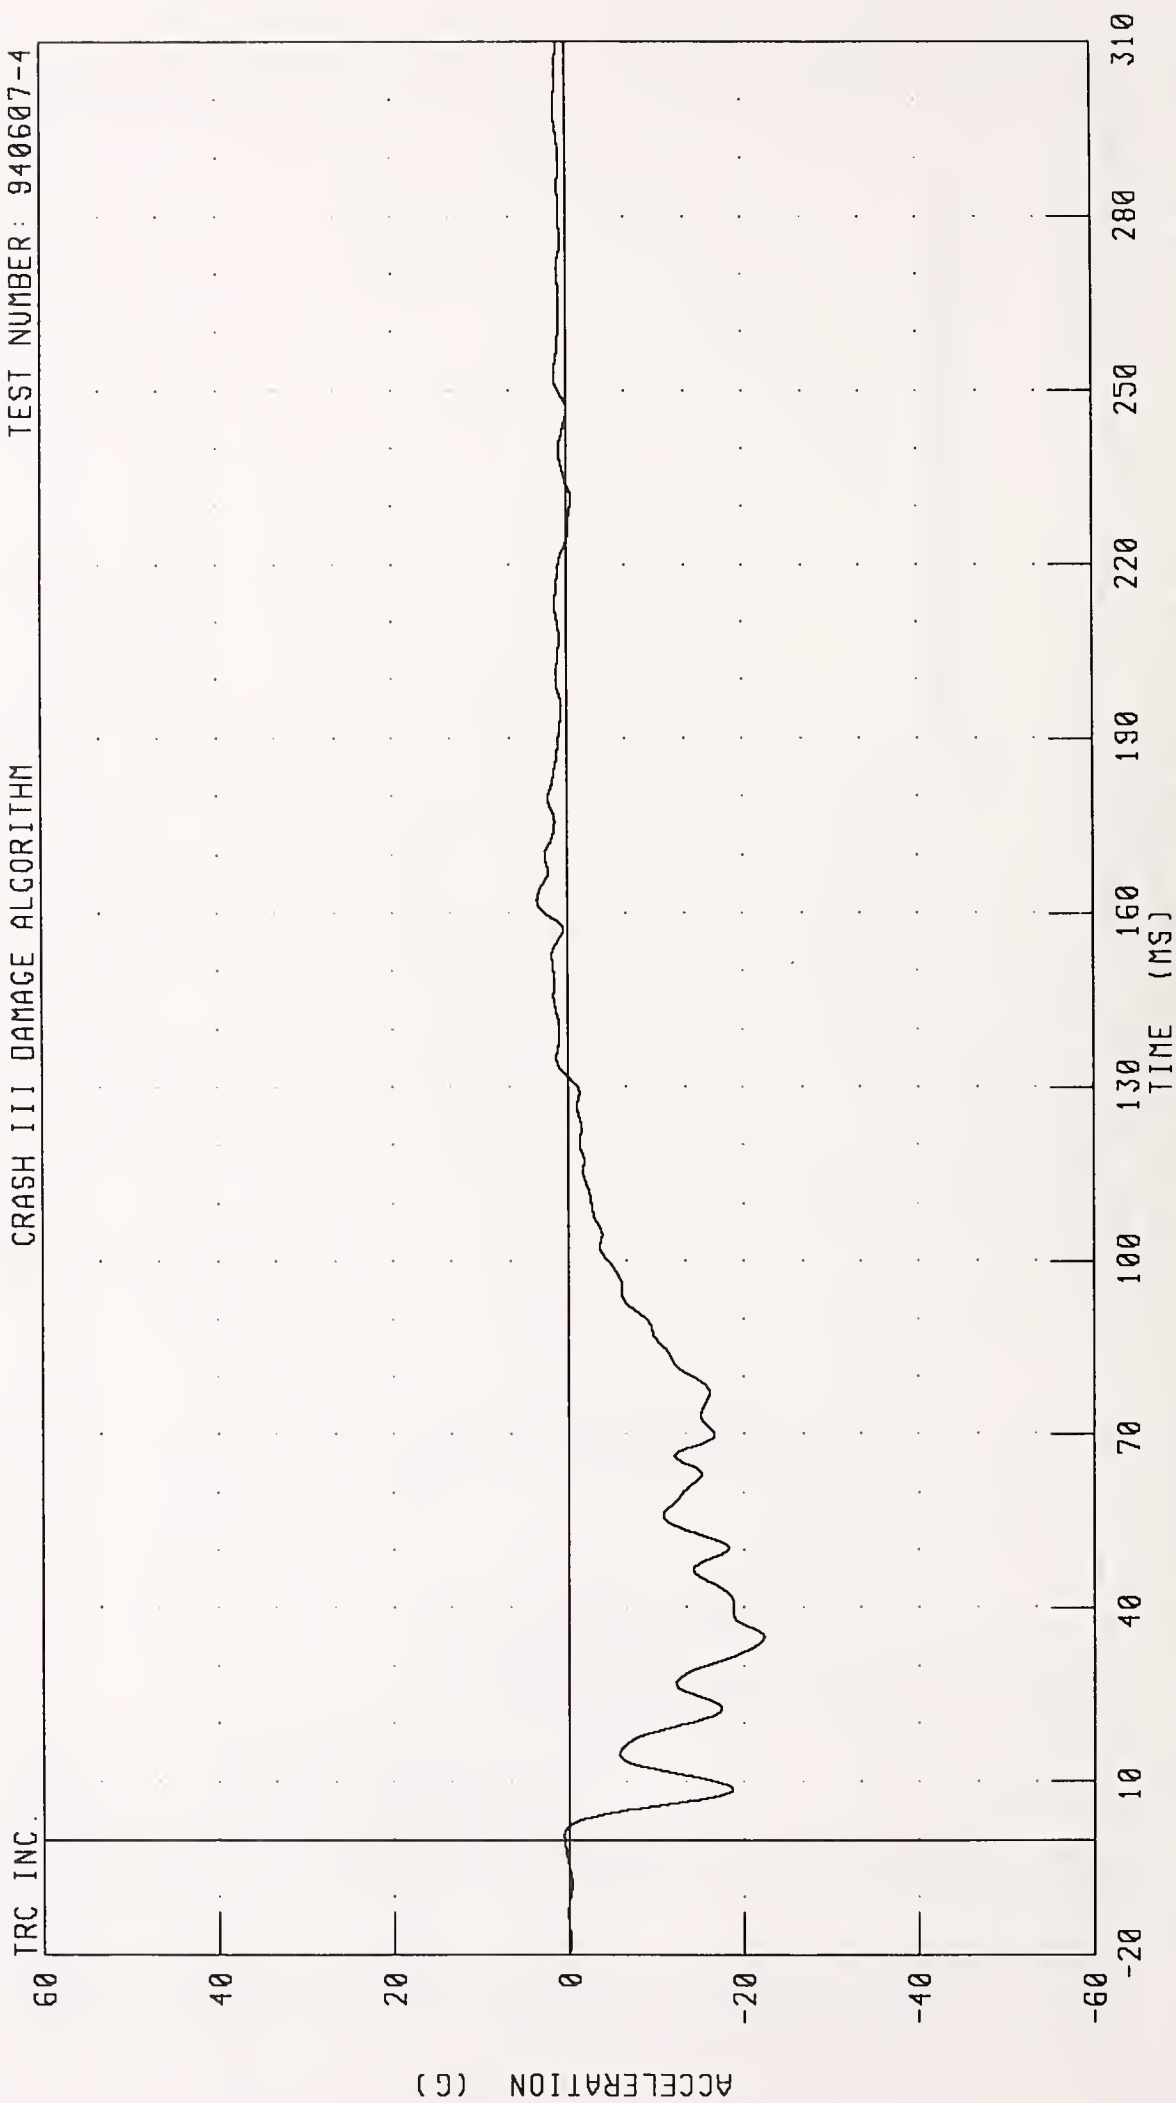
CHANNEL: LRSXG1 FILTER: CH. CLASS 60

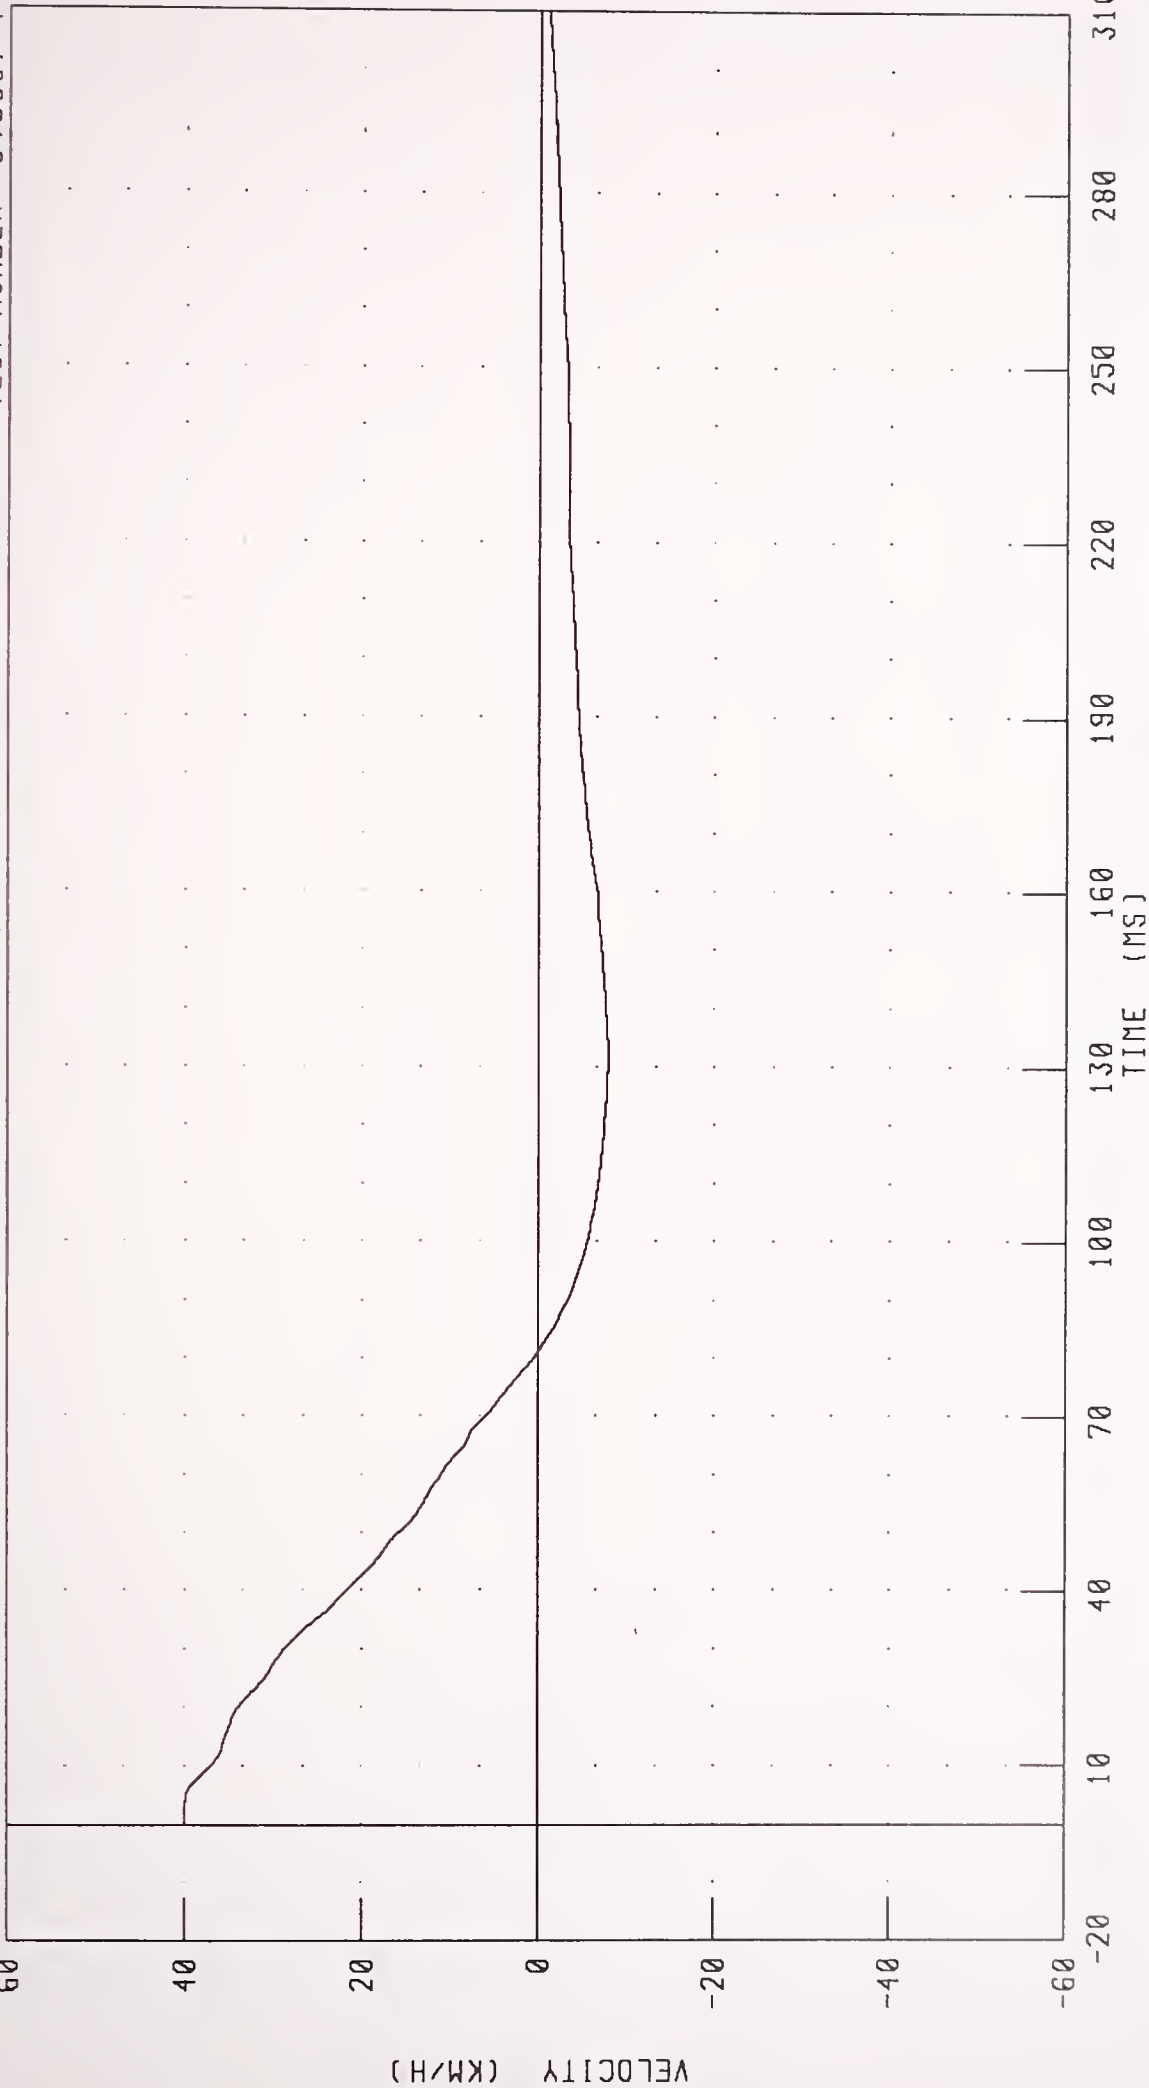
CHANNEL: LRSXV1 FILTER: CH. CLASS 180

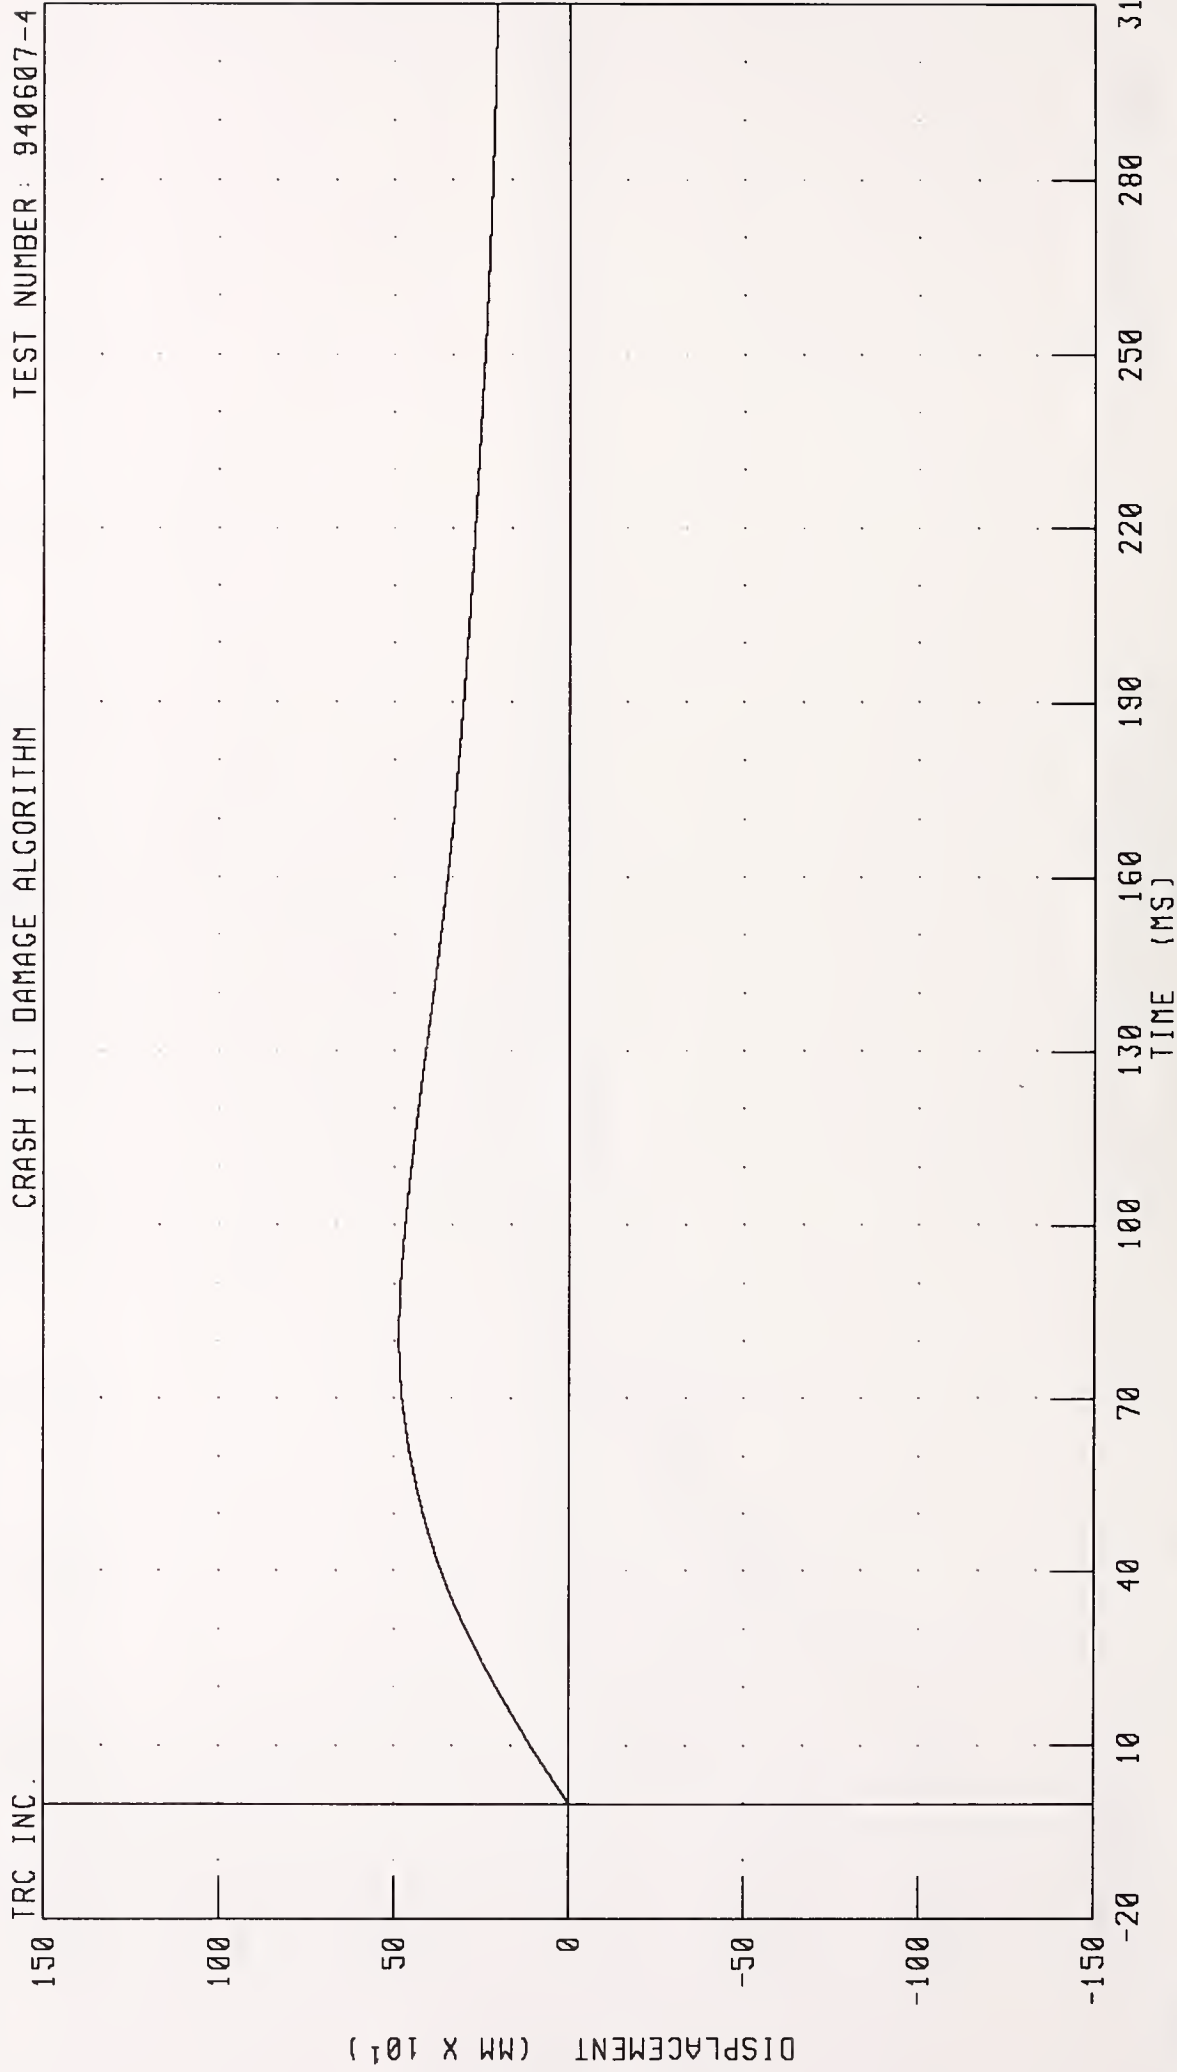
CHANNEL: LRSXD1 FILTER: CH. CLASS 180

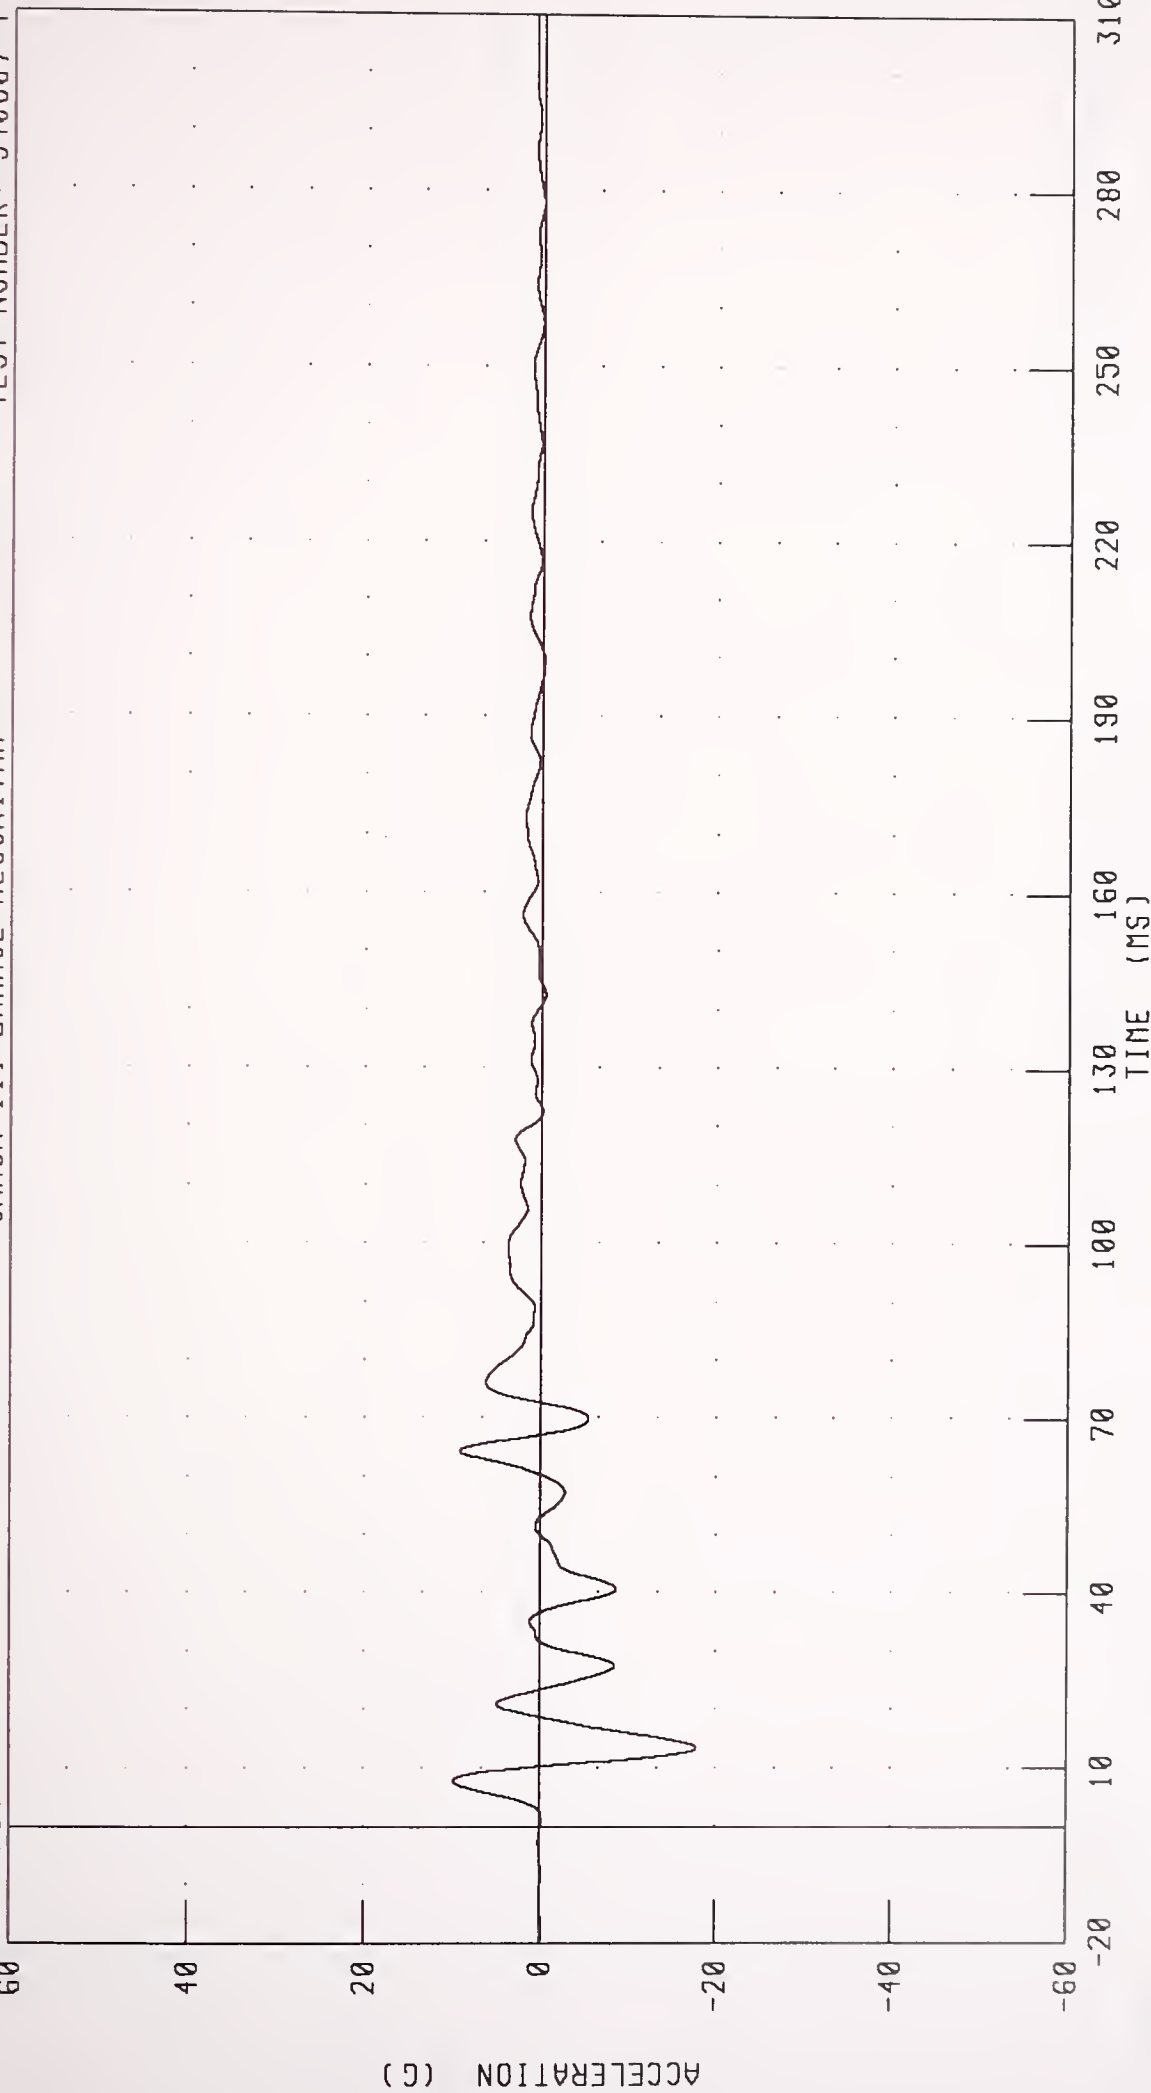
CHANNEL: LRSYG1 FILTER: CH. CLASS 60

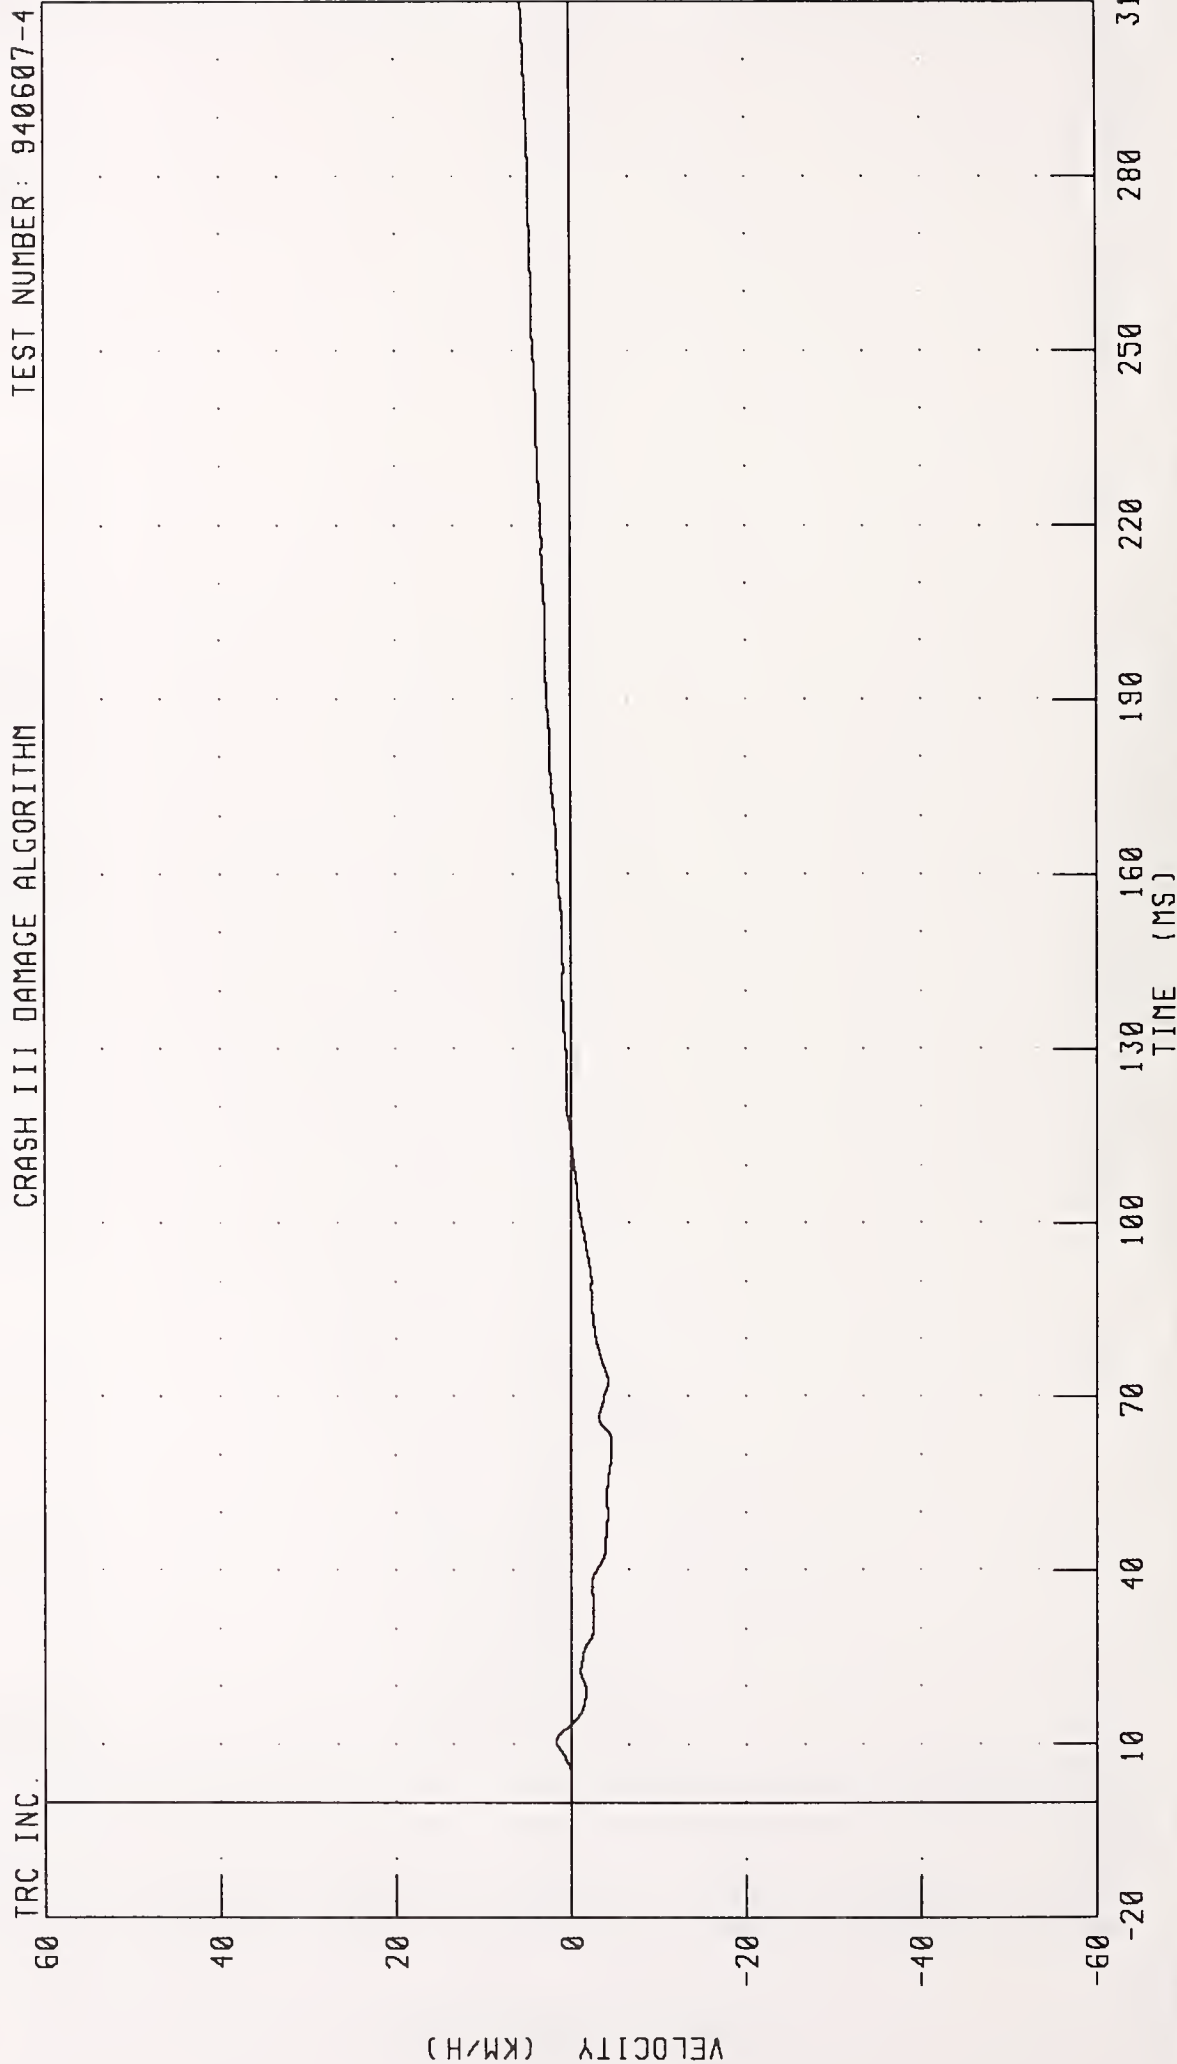
CHANNEL: LRSYV1 FILTER: CH. CLASS 180

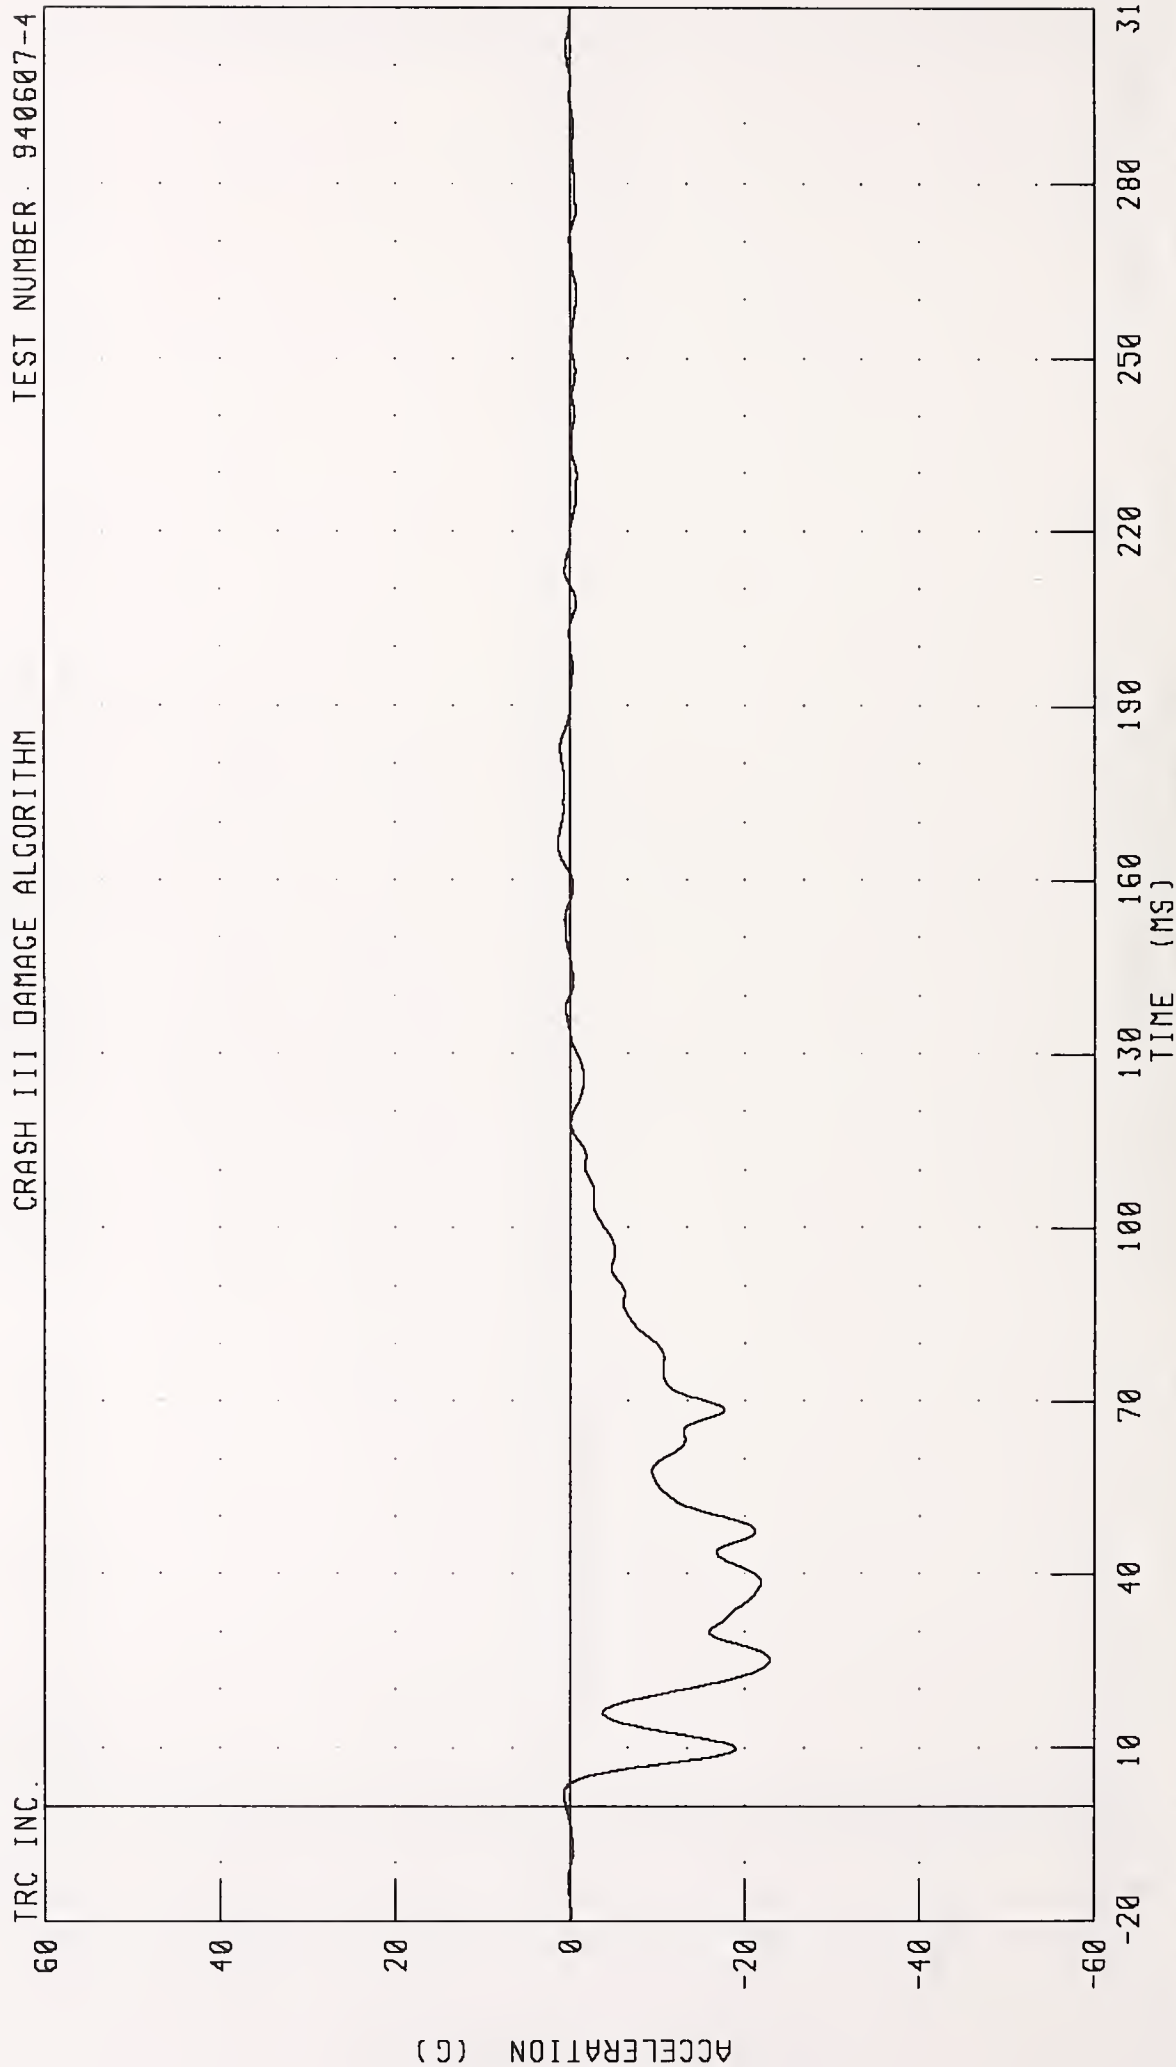
CHANNEL: RRSXG1 FILTER: CH. CLASS 60

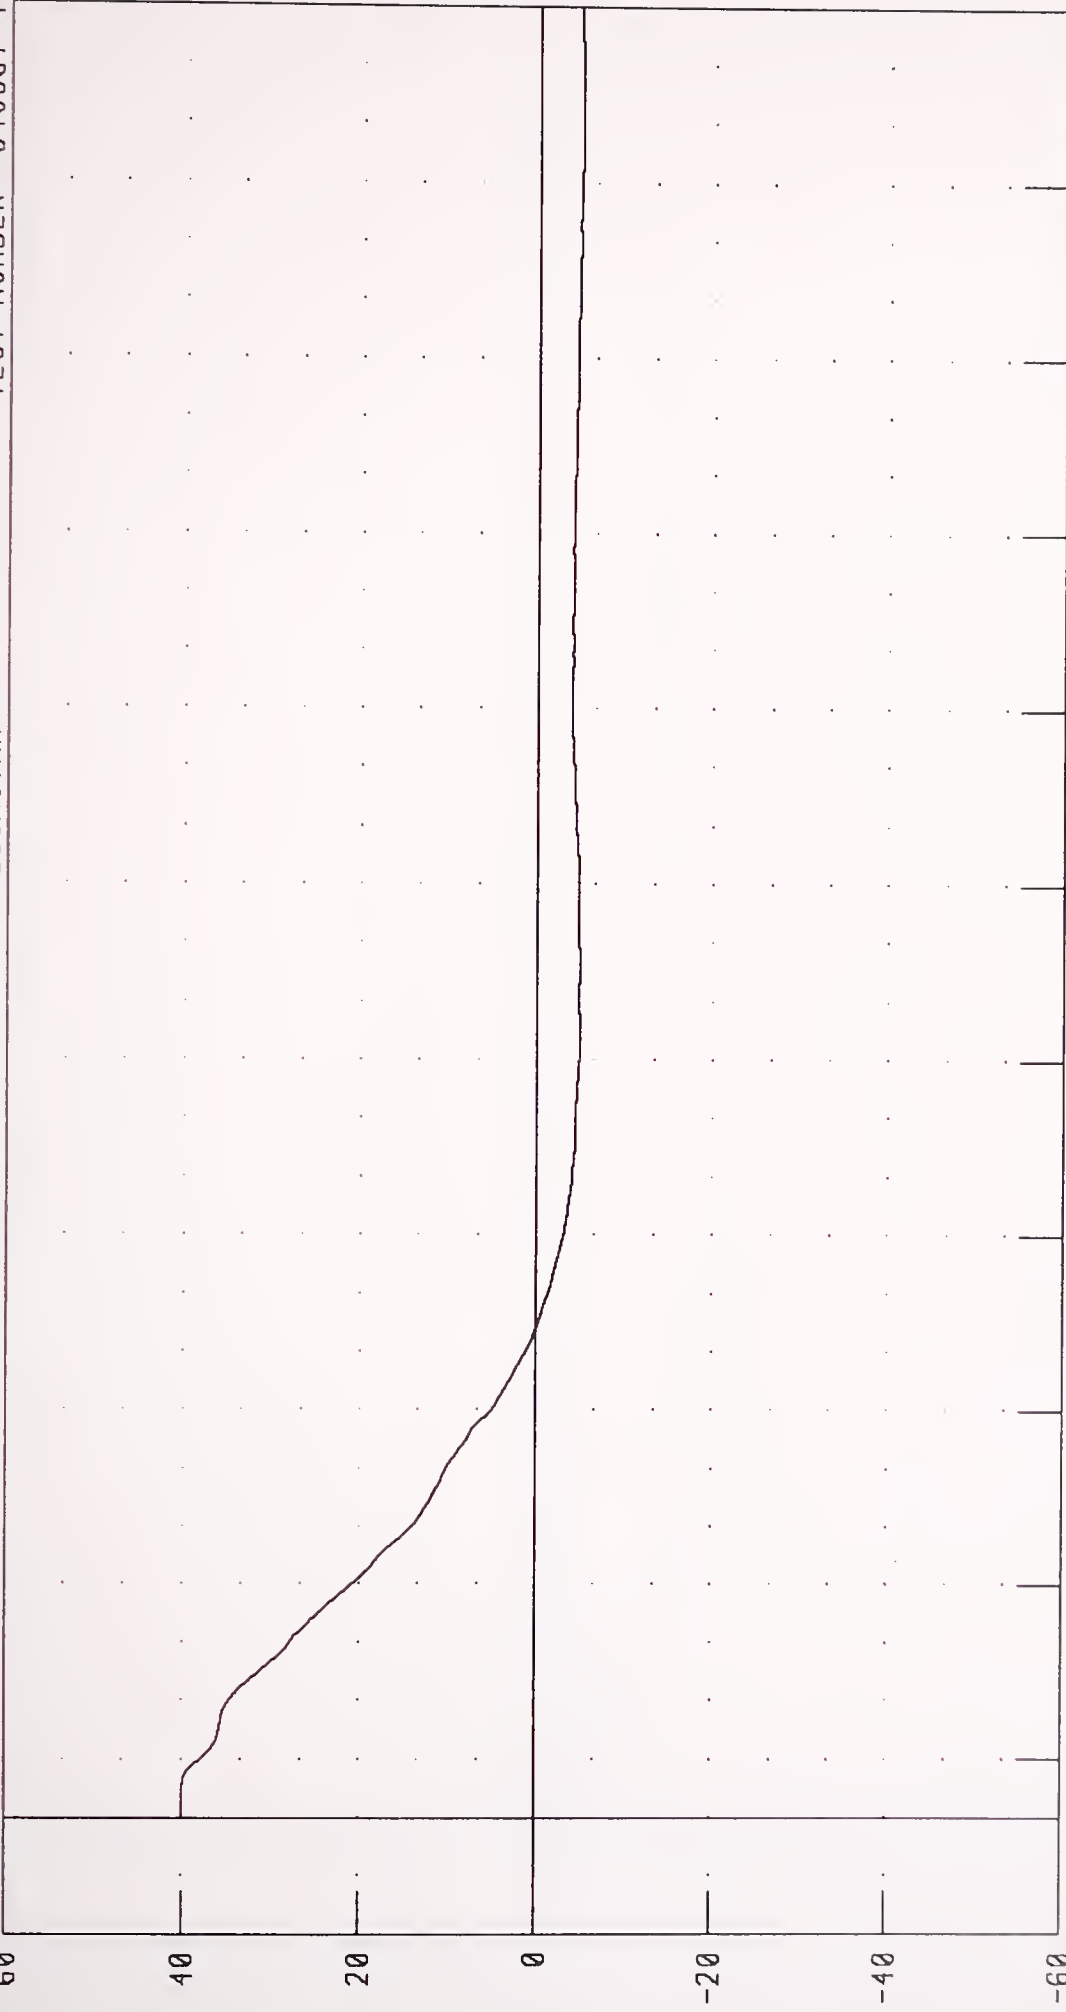
1990 CHEVROLET CAPRICE INTO 50% LEFT OFF-SET FRONTAL BARRIER TEST NO. 4  
 RIGHT REAR SILL X-AXIS DISPLACEMENT
